NAVORD REPORT 2932

INVESTIGATION OF MARK 18 TORPEDO FAILURES

25 AUGUST 1953

By:
Richard H. Stresau
L. E. Starr

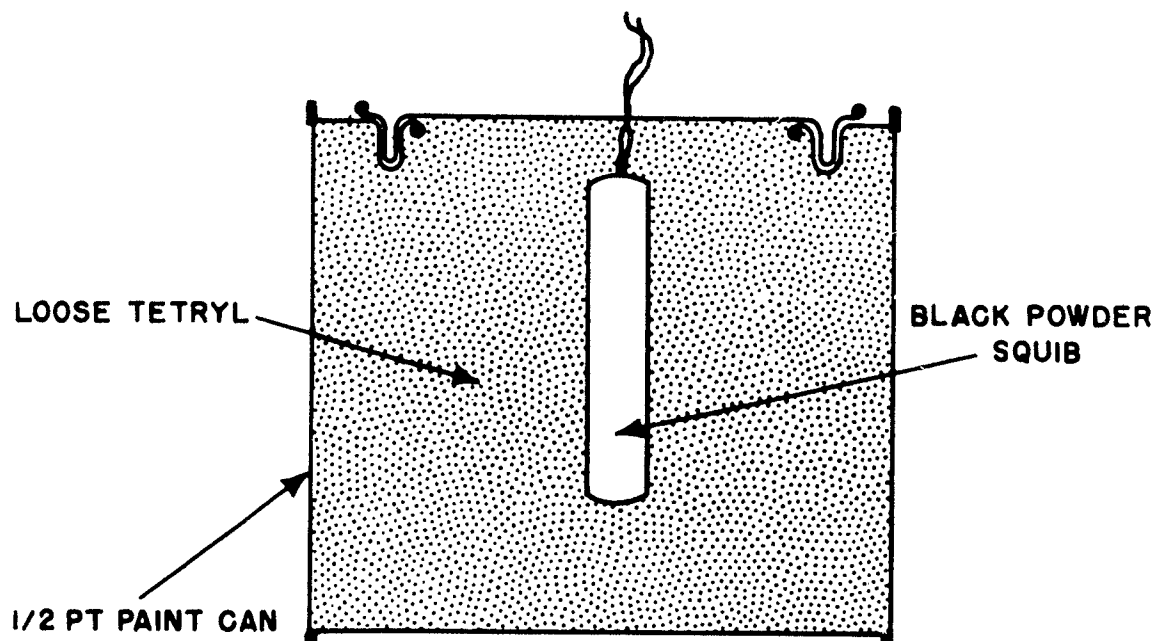
FIG.3 LOOSE TETRYL CONFINEMENT TEST

12. When confined in the paint cans, the tetryl only reacted vigorously enough to open the can. Under the higher confinement of the pipe nipple, however, the action was much more violent than that which would result from a pressure sufficient to merely burst the pipe. The pipe was broken into fragments about the size of a quarter and the dent produced in a steel plate upon which the assembly rested was of the order of magnitude of that which the detonation of an equivalent quantity of tetryl might produce.

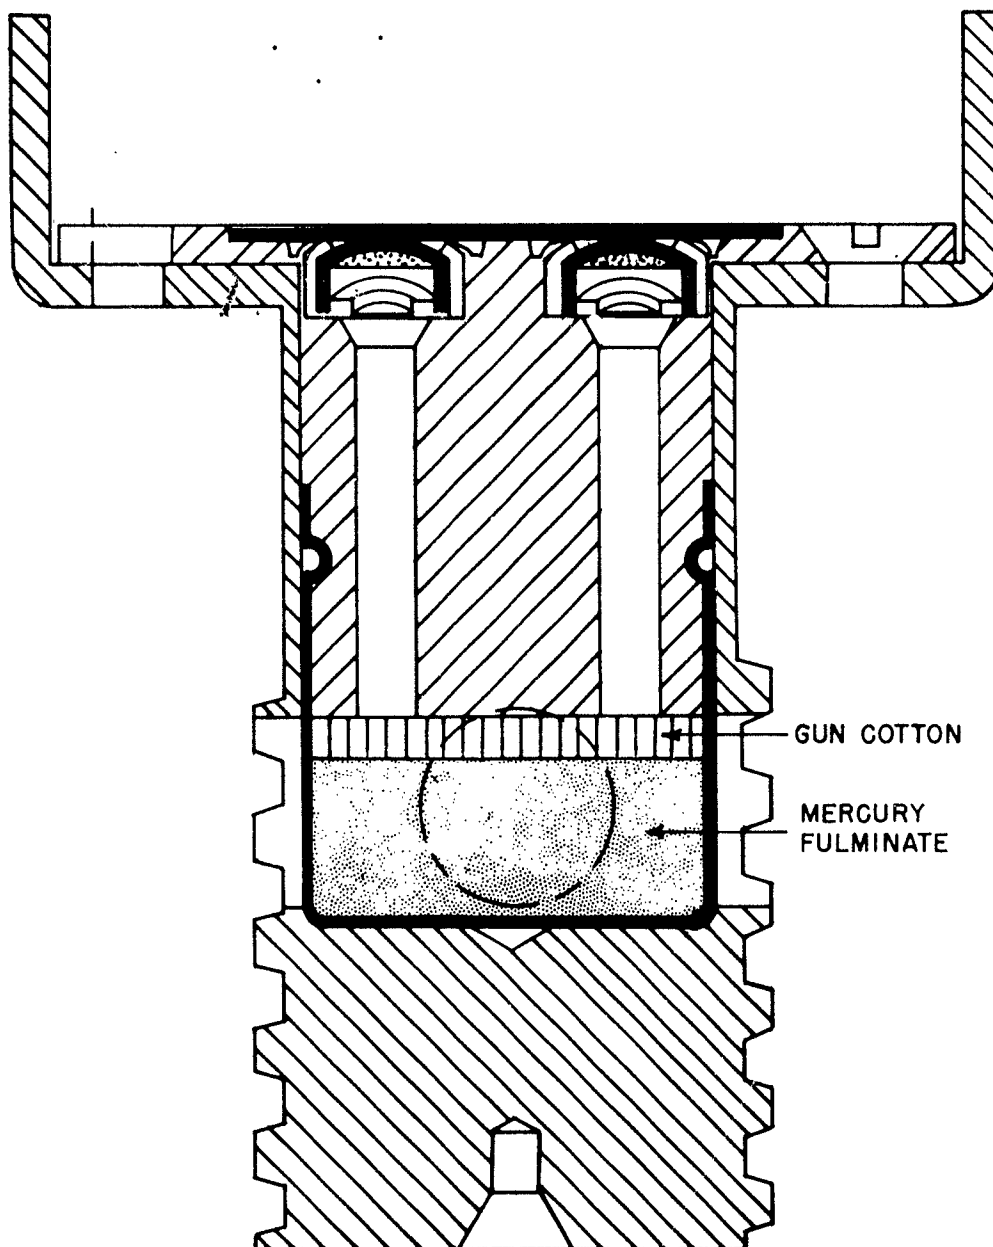
FIG. 7
DETONATOR MK 8 MOD 3

19. It will be noted that of the total of 66 trials all 13 low order actions occurred when Mk 8 Mod 3 base charges were used. The probability of this occurring as the result of chance distribution of systems prone to failure for a reason other than detonator trouble, such as faulty boosters, for example, is only one in 20,000. The fact that 8 high order detonations occurred in 8 trials with the XE-12A detonators, Figure 10, which contain only about one fifteenth as much explosive as the Mk 8 detonators is an indication that the low orders were caused by a difference in kind of reaction of the detonator rather than merely a difference in degree.

21. The results obtained with the mercuric fulminate when initiated by the electric initiators, Figure 9, would seem to contradict the opinion stated above. However, the electric initiators used contained 25 mg of lead azide which is ample to establish detonation in this material. It would seem that one of the first results of deterioration of mercuric fulminate is the reduction in its tendency to make the transition from burning to detonation. It is known that very small changes in loading density can have large effects upon this tendency. The considerable effect of a small amount of dextrin in lead azide is an indication that impurities can also have a serious effect. The inescapable conclusion of these tests is that the major source of the low order action observed in these and the Hawaiian tests is the mercuric fulminate base charge in the Mk 8 Mod 3 detonator.

(1) All Mk 8 Mod 3 detonators be replaced by Mk 8 Mod 4 detonators.

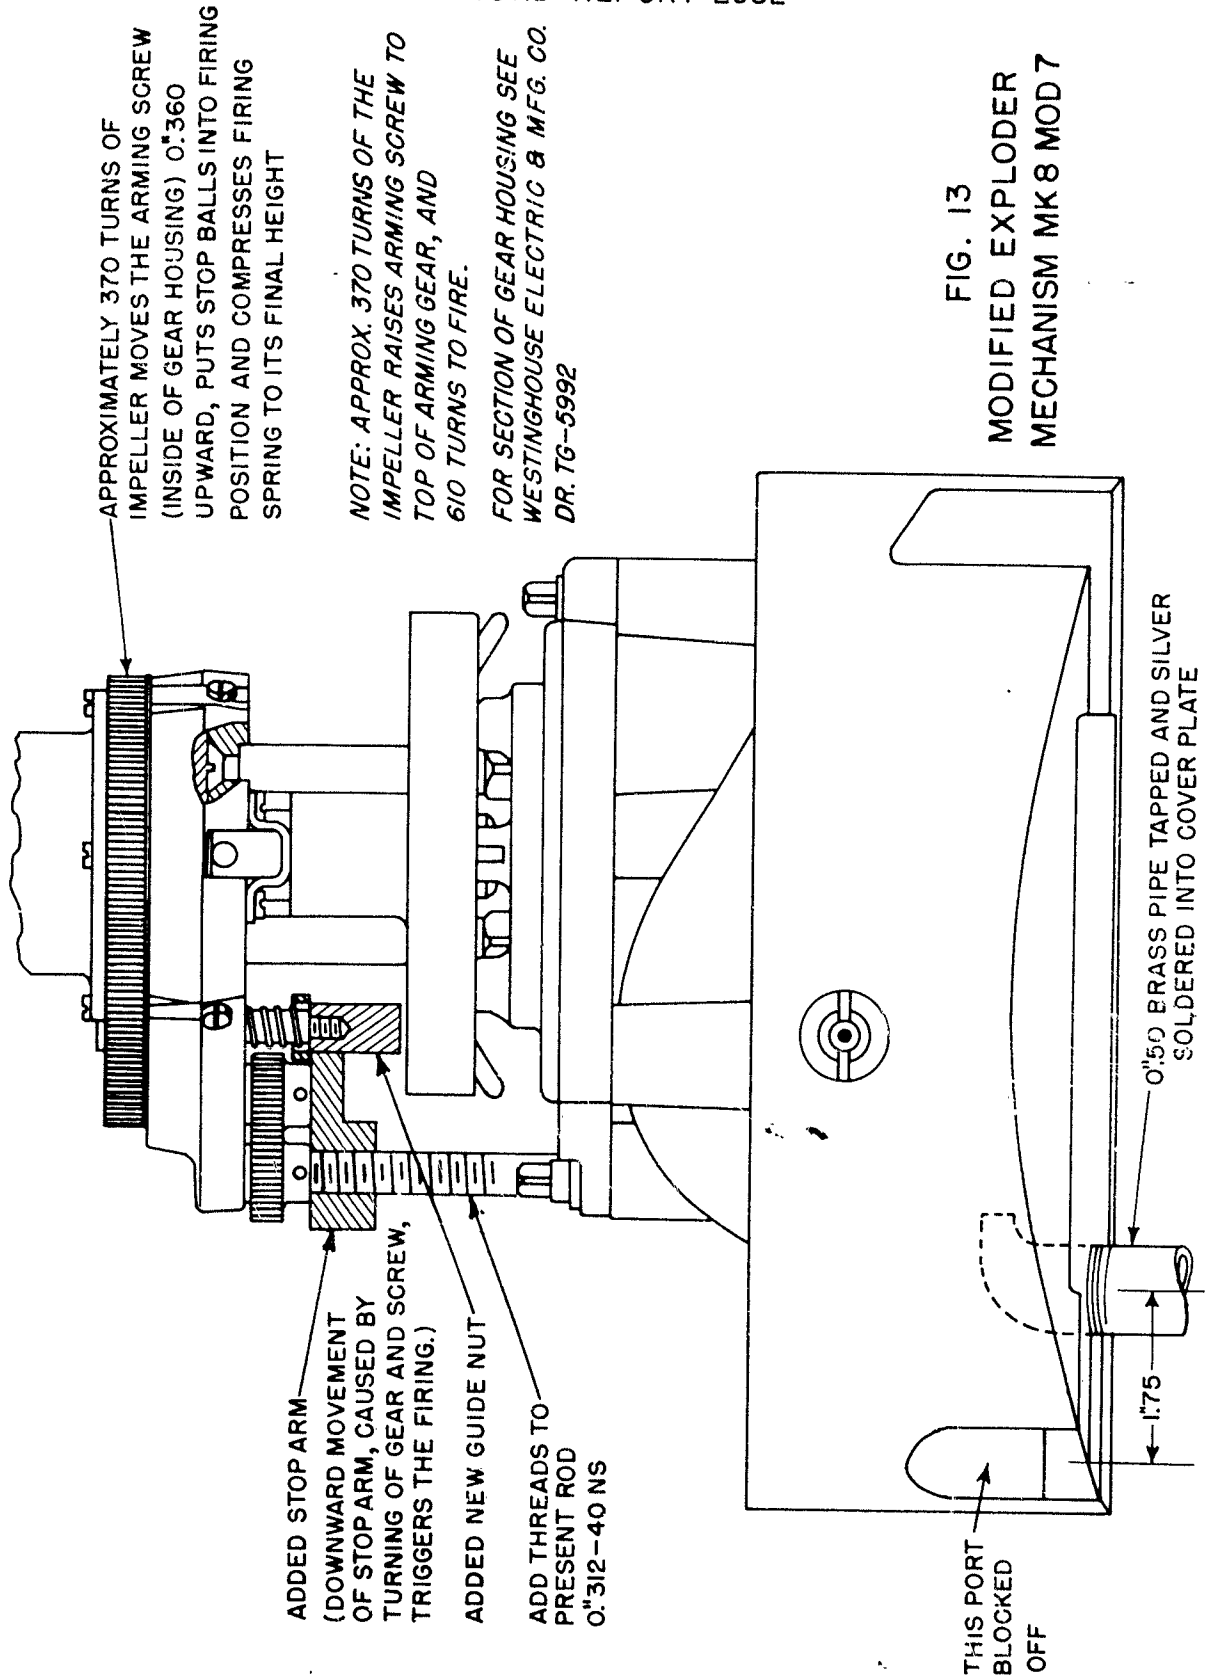
FIG. 13
MODIFIED EXPLODER
MECHANISM MK 8 MOD 7

25. A group of exploders, Mk 8 Mod 7, were modified as shown in Figure 13, and in more detail in reference (d), for use by the Naval Proving Ground, Dahlgren, Virginia, in fully loaded warheads. The modifications made it possible to arm and fire the exploders by means of water conducted to the mechanism by a hose. The water was pumped by means of a fire engine through about 1,000 feet of fire hose and 50 feet of garden hose. The garden hose was used for the last 50 feet because it was considered to be more expendible. The warheads were set up as shown in Figures 14 and 15 so that in case of a failure, the exploder could be removed from a distance by pulling the rope.

26. The pressure drop in the garden hose was such that only five of the ten exploder mechanisms would operate satisfactorily. Some of the mechanisms were so stiff that it is doubted that they would work in service.

27. After adjusting and lubricating the exploders and installing the nozzles shown in dotted lines on Figure 13, four of the remaining five exploders were made to operate satisfactorily.
